NAVIGATION - GARMIN SOFTWARE UPDATE TO VERSION 4.8.11

525 (Citation M2)

-0685, -0800 thru -1047

SB525-34-97
Page 1 of 3

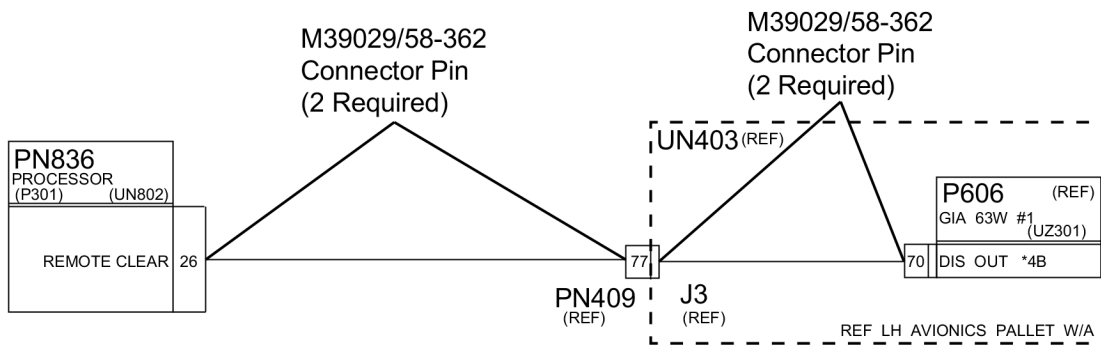
Figure 1. Wiring Modification (Sheet 1)

Airplanes Equipped with the Stormscope Option

- G. Remove the PN409 electrical connector from the left avionics pallet.
 - H. (Refer to Figure 1, Sheet 1.) Install the 26PN836-77PN409 Electrical Wire using two M39029/58-362 Connector Pins.
