NAVIGATION - GARMIN SOFTWARE UPDATE TO VERSION 4.8.11

525B (CJ3+)

March 26, 2021

SB525B-34-32
Page 1 of 3

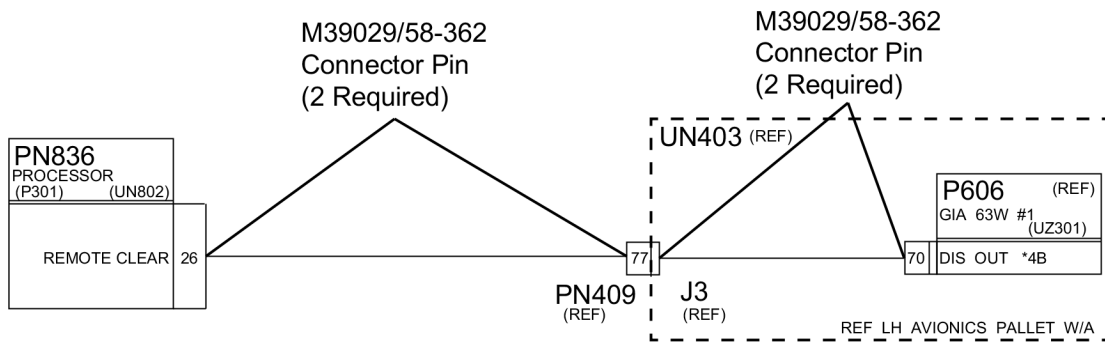
Figure 1. Wiring Modification (Sheet 1)

Airplanes Equipped with the Stormscope Option

- G. Install the 26PN836-77PN409 Electrical Wire with two MS39029/58-362 Connector Pins.
 - H. Install the 77J3-70P606 Electrical Wire using two M39029/58-362 Connector Pins.
